FAR Sensor Trial Chertsey 2025-26 - Ryegrass

Monday 13 Oct 2025

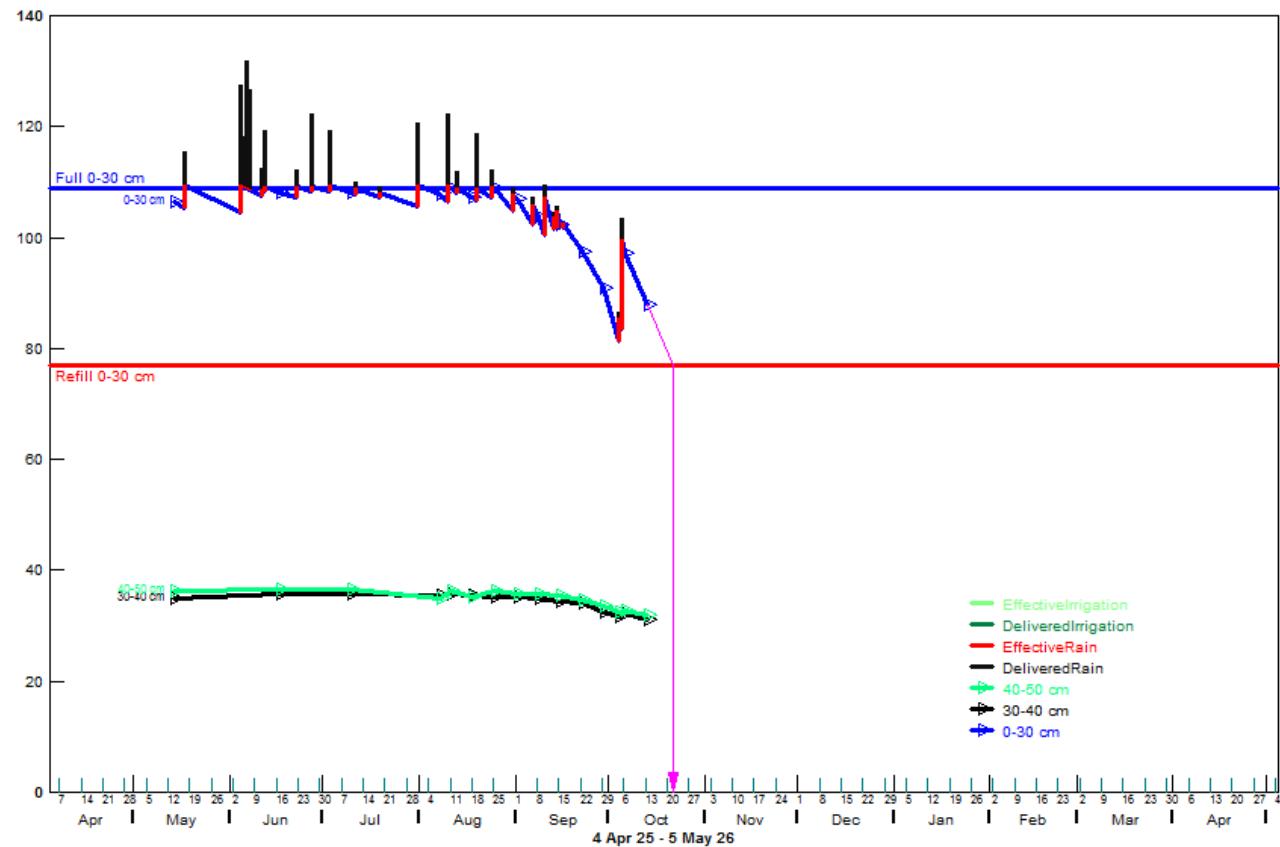
RootZone	Full	REFILL	Previous	Current	Deficit	Probe Dwu	Pdwu Date	EDWU	Date	Amount
0-30 cm	109 mm	77 mm	97 mm	88 mm	21 mm	1.3 mm/day	22 Oct	1.3 mm/day	22 10 0:28	32 mm
